# **Factsheet**

BEST\_IIG\_Sillblock

Name and address	BEST 3   "Sillblock"	- Sebastian-S	Scheel Stra	ße 18-18b
Map	Source: <a href="http://city-Asocial housing color: blue;">http://city-Asocial housing color: blue;</a>			has been refurbished
<b>-</b>	were exchanged a maintained where e installed to enab Decentralized ventil flats. In addition, se	gainst electr xisting from b le some a lation system everal addition ated in the ref	ric panels before. A P\ mount of s were imp nal improve	but gas heating was /-plant on the roof was energy self-supply. lemented in 1/3 of the ements to the building t process, such as new
Ownership	Innsbrucker Immob			
Gross conditioned	2,115 m <sup>2</sup>	Treated flo (TFA) (PHF		1791 m²
Number of	34			
Heating demand (EPC¹)	BEFORE RENOVATION		193,3 3 k	
	TARGET/AFTER RENOVATION 19		19,7 kWh	n/m²*a
Heating demand	BEFORE RENOVATION	ON	151 kWh/	′m²*a

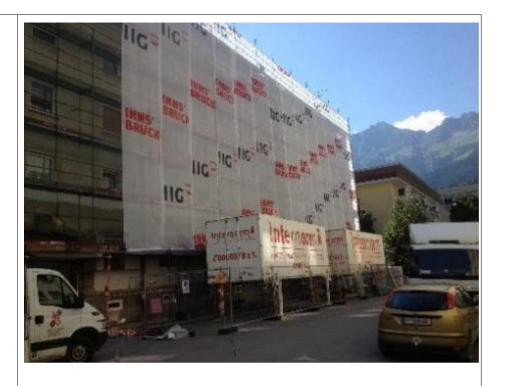
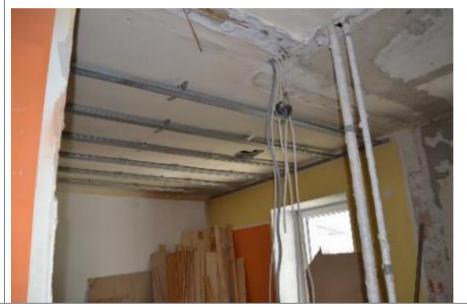
Work progress	
Important points of refurbishment process and short description	You may find here three pictures of the construction process showing some steps of the external and internal refurbishment process. It shows activities of the façade insulation, of preparation and implementation of the ventilation system.
